**Flood Control Project Maintenance
Levee Inspections**
LMA District Cover Sheet
Spring 2018 Levee Inspection Results

Sutter Maintenance Yard East-West Interceptor

Spring 2018 Levee Inspection Results

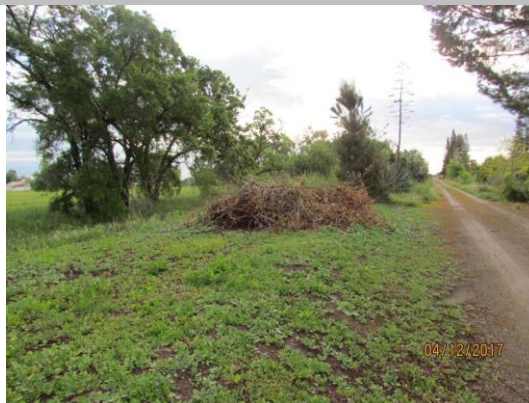
Photo 1 of 1 : SP_2018_ST0020_213_12_20180305_00006.jpg

View of the prunings along the waterside slope.

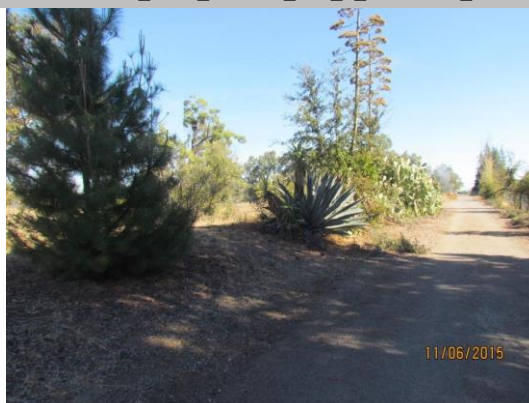
Photo 1 of 2 : SP_2018_ST0020_213_2_20180305_00002.jpg

LM Start	0.23	Rating **	M	Issue No.	2
LM End	0.25	Issue Type +	En	Location *	CR
Category	Earthen Levee			GPS Latitude/Longitude	
				Start	End
Item	Vegetation			39.171418 °	39.171408 °
				-121.755963 °	-121.755578 °
DWR ID	DWR_NA0020_01_s _ 2012_2				
Comment Code					
V6 : Landscaping					
Inspector Comment					
Remove the cactus and pine trees from the waterside berm.

View of the cactus and pine trees along the waterside berm.

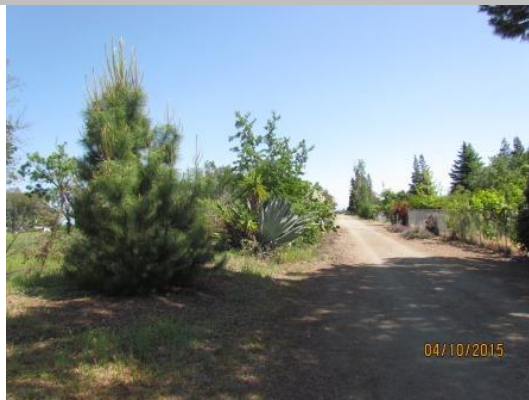
Photo 2 of 2 : SP_2018_ST0020_213_2_20180305_00003.jpg

Another view of the cactus and pine trees along the waterside berm.

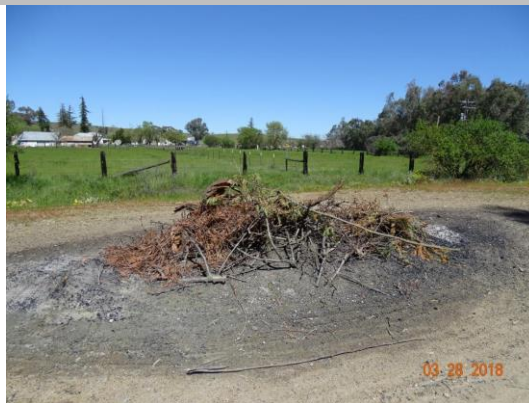
Photo 1 of 1 : SP_2018_ST0020_213_7_20180403_00022.jpg

View of the prunings along the crown.

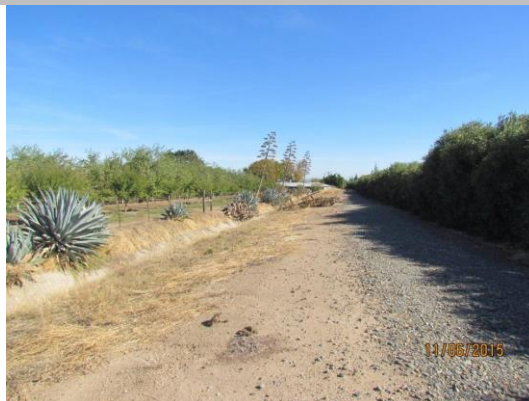
Photo 1 of 1 : SP_2018_ST0020_213_1_20180305_00001.jpg

View of the cactus tree that has fallen on the waterside slope.

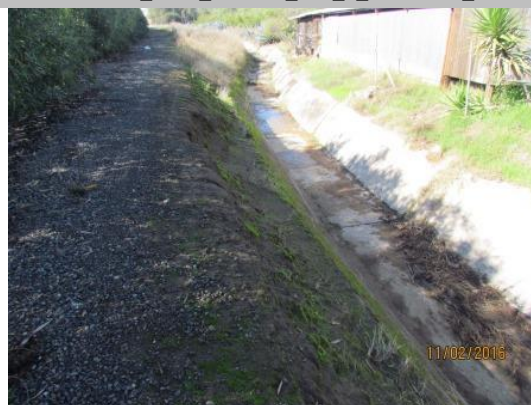
Photo 2 of 2 : SP_2018_ST0020_213_4_20180305_00005.jpg

Another view the erosion along the concrete ditch.

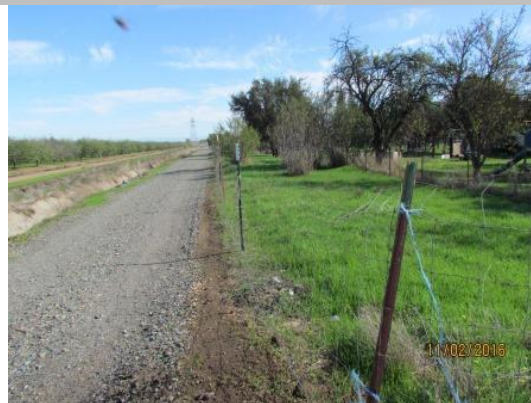
Photo 1 of 1 : SP_2018_ST0020_213_16_20180305_00010.jpg

View of an unauthorized fence by a landowner.

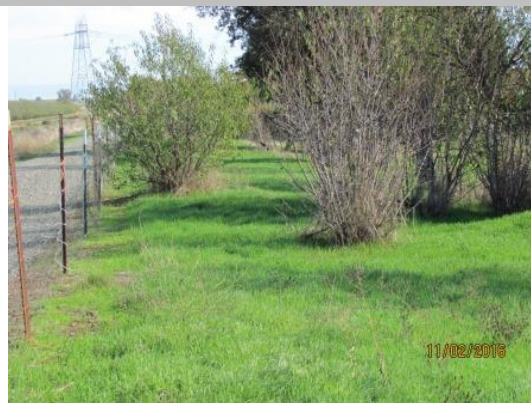
Photo 1 of 1 : SP_2018_ST0020_213_17_20180305_00011.jpg

LM Start	0.94	Rating **	M	Issue No.	17
LM End	0.98	Issue Type +	En	Location *	LS
Category	Earthen Levee			GPS Latitude/Longitude	
				Start	End
Item	Encroachments			39.171333 °	39.171333 °
				-121.742577 °	-121.741827 °
DWR ID	DWR_ST0020_01_f_2016_17				
Comment Code					
CR : Crops					
Inspector Comment					
Ask the landowner to remove the nut trees.

View of the nut trees planted by a landowner.

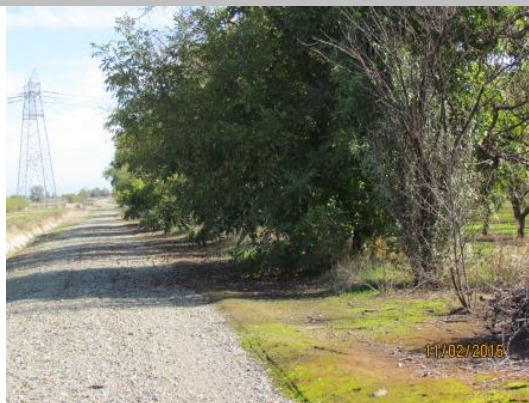
Photo 1 of 1 : SP_2018_ST0020_213_18_20180305_00012.jpg

LM Start	1.11	Rating **	M	Issue No.	18
LM End	1.28	Issue Type +	Ma	Location *	LS
Category	Earthen Levee			GPS Latitude/Longitude	
				Start	End
Item	Trim / Thin Trees			39.171283 °	39.171243 °
				-121.739315 °	-121.736312 °
DWR ID	DWR_ST0020_01_f_2016_18				
Comment Code					
T1 : Trim trees to at least five feet above ground level.					
Inspector Comment

View of the trees blocking visibility.

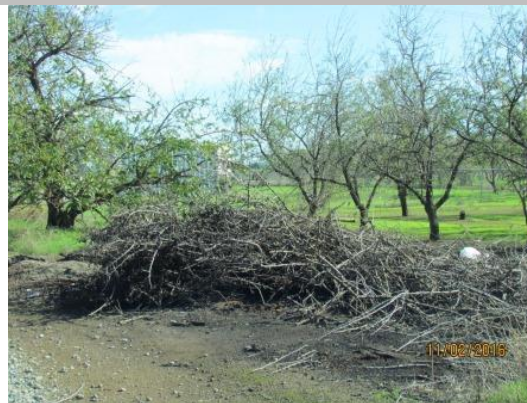
Photo 1 of 1 : SP_2018_ST0020_213_21_20180305_00014.jpg

View of the prunings along the landside toe.

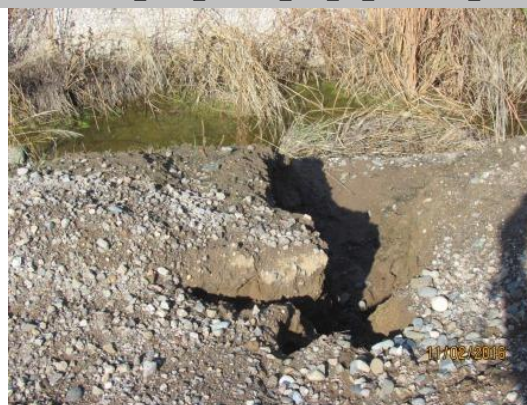
Photo 1 of 1 : SP_2018_ST0020_213_22_20180305_00015.jpg

LM Start	1.33	Rating **	M	Issue No.	22
LM End	1.33	Issue Type +	Ma	Location *	WS
Category	Earthen Levee			GPS Latitude/Longitude	
				Start	End
Item	Erosion / Bank Caving			39.171218 °	39.171218 °
				-121.735258 °	-121.735258 °
DWR ID	DWR_ST0020_01_f_2016_22				
Comment Code					
E1 : Note and monitor erosion site.					
Inspector Comment

View of the erosion along the bank.

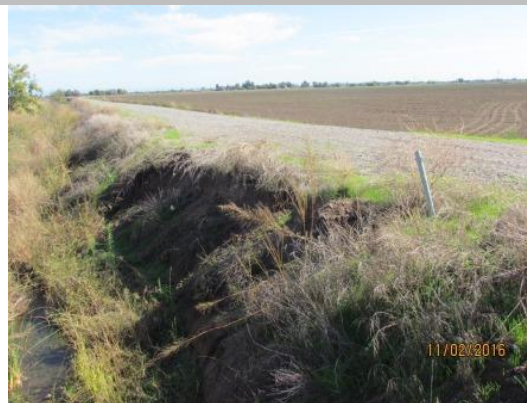
Photo 1 of 1 : SP_2018_ST0020_213_24_20180305_00016.jpg

LM Start	1.36	Rating **	M	Issue No.	24
LM End	1.36	Issue Type +	Ma	Location *	WS
Category	Earthen Levee			GPS Latitude/Longitude	
				Start	End
Item	Erosion / Bank Caving			39.171220 °	39.171220 °
				-121.734730 °	-121.734730 °
DWR ID	DWR_ST0020_01_f_2016_24				
Comment Code					
E1 : Note and monitor erosion site.					
Inspector Comment

View of the erosion along the bank.

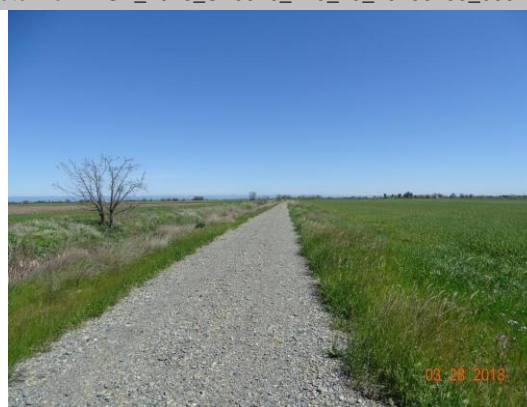
Photo 1 of 1 : SP_2018_ST0020_213_13_20180403_00023.jpg

View of the native grasses on both slopes.

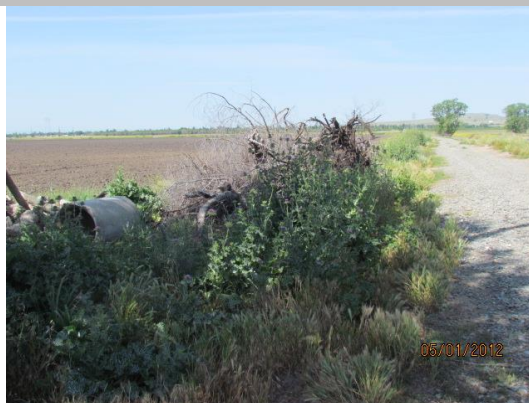
Photo 1 of 1 : SP_2018_ST0020_214_9_20180305_00006.jpg

LM Start	0.26	Rating **	M	Issue No.	9
LM End	0.26	Issue Type +	En	Location *	LS
Category	Earthen Levee			GPS Latitude/Longitude	
				Start	End
Item	Encroachments			39.171101°	39.171101°
				-121.721856°	-121.721856°
DWR ID	DWR_NA0020_02_s_2012_9				
Comment Code					
DE : Debris					
Inspector Comment

View of the debris along the landside toe.

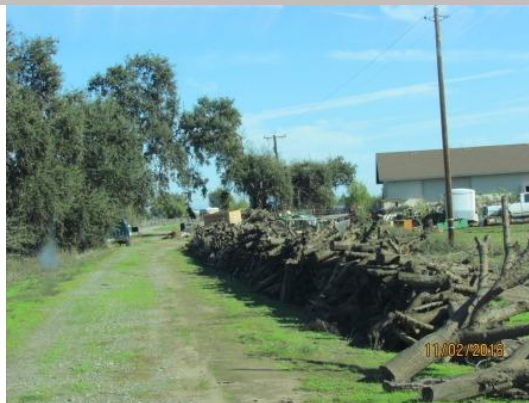
Photo 1 of 1 : SP_2018_ST0020_214_32_20180305_00013.jpg

View of the firewood along the landside toe.

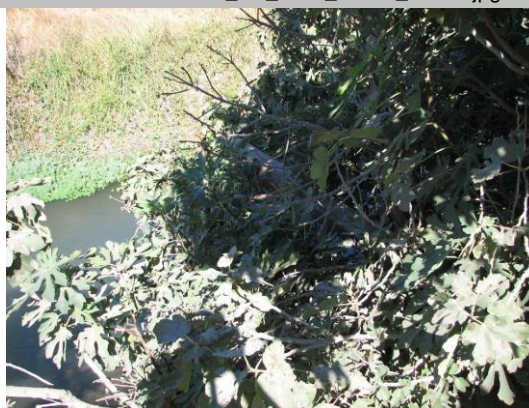
Photo 1 of 3 : UCIP_SP_2018_51533_11363.jpg

Comment Code						
Inspector Comment						
FS_ID:51533 DS_ID:19425 EP_NO: N/A Repair Type: Non-Urgent Crossing Status: Found UCIP Comments: 4/10/2017 Abandoned. (DWR Sutter Yard-AFreitag)10/11/2016 Abandoned crossing.(DWR Sutter Yard -afreitag)4/19/2016 Abandoned crossing.5/12/2015 Abandoned crossing.11/17/2014 Same as last inspection.5/12/2014 Same as last inspection.11/4/2013 Same as last inspection.5/15/2013 Same as last inspection.10/16/2012 Pipe and pump abandoned. Pipe should be removed or properly abandoned. FIELD_STRUCT_DESC: 8-inch galvanized iron irrigation pipe through the levee, 2 feet below the crown. 7.5 horsepower (HP) pump located in canal on the waterside (WS). [Additional Reference(s): DWR Levee Log, 1990. USACE Sacramento O&M Manual 135 (revision), May 1953, (HLM 0.39), Page 11, Location Section 12, As-Built Drawing No. 50-10-2816]. FS Date: 4/12/2017 12:04:00 PM

Pipe on LS slope.

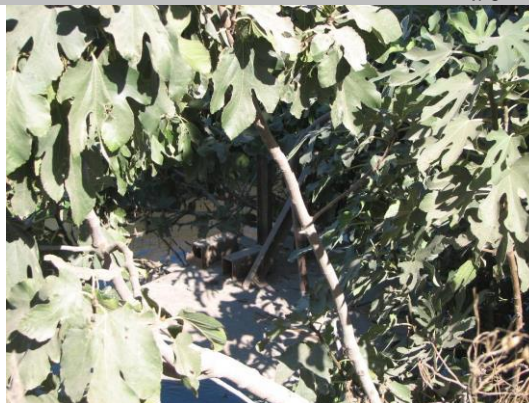
Photo 2 of 3 : UCIP_SP_2018_51533_11362.jpg

Pump platform on LS slope.

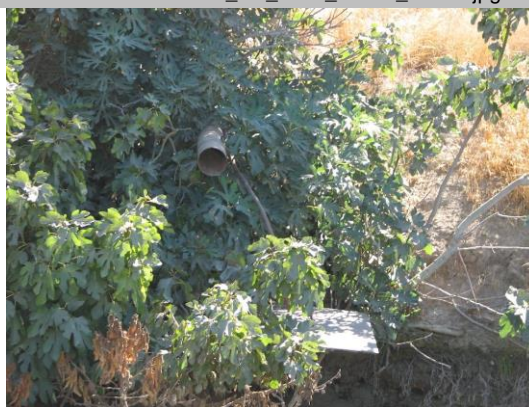
Photo 3 of 3 : UCIP_SP_2018_51533_11361.jpg

View of pipe from unprotected side of levee.

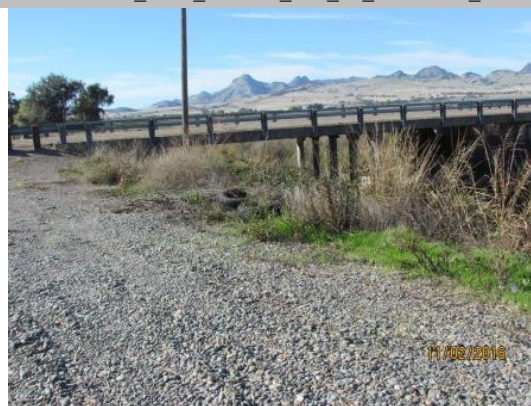
Photo 1 of 1 : SP_2018_ST0020_214_28_20180305_00011.jpg

View of the tires along the waterside berm.

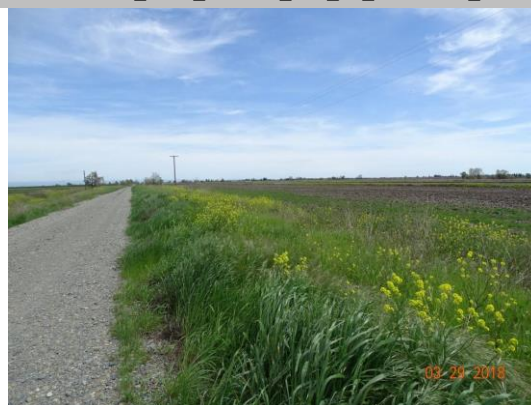
Photo 1 of 2 : SP_2018_ST0020_214_19_20180403_00043.jpg

View of the vegetation along the landside slope.

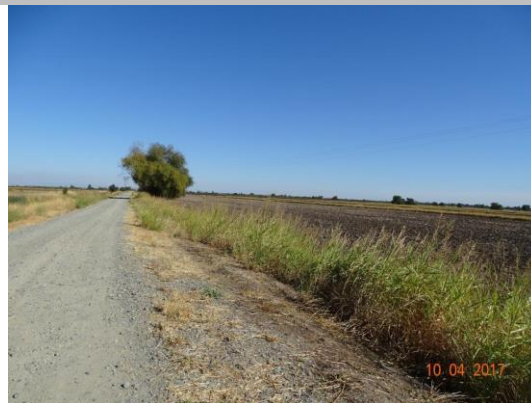
Photo 2 of 2 : SP_2018_ST0020_214_19_20180305_00009.jpg

View of the vegetation along the landside slope.

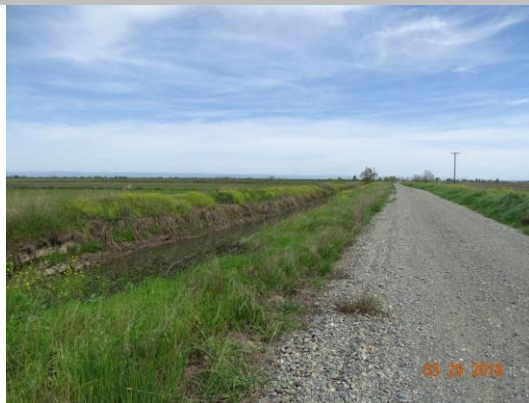
Photo 1 of 2 : SP_2018_ST0020_214_20_20180403_00044.jpg

View of the native vegetation on the waterside slope.

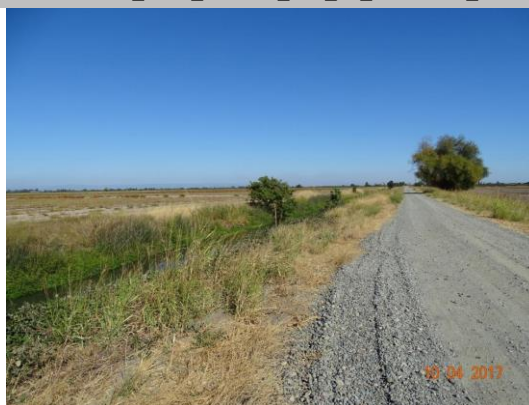
Photo 2 of 2 : SP_2018_ST0020_214_20_20180305_00010.jpg

View of the native vegetation on the waterside slope.

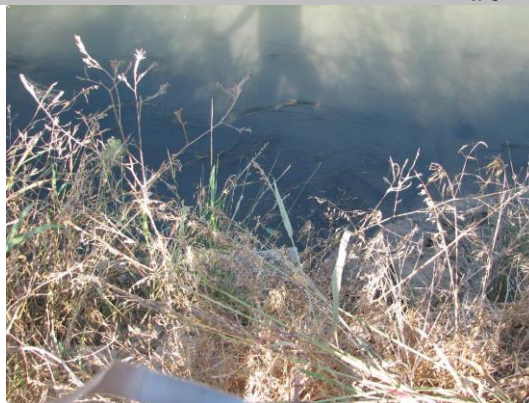
Photo 3 of 3 : UCIP_SP_2018_51534_11389.jpg

Comment Code						
Inspector Comment						
FS_ID:51534 DS_ID:19426 EP_NO: N/A Repair Type: Non-Urgent Crossing Status: Found UCIP Comments: 4/10/2017 Abandoned. (DWR Sutter Yard-AFreitag)10/11/2016 Abandoned crossing.(DWR Sutter Yard -afreitag)4/19/2016 Abandoned crossing.5/12/2015 Abandoned crossing. Needs to be properly abandoned.11/17/2014 Same as last inspection.5/12/2014 Same as last inspection.11/4/2013 Same as last inspection.5/15/2013 Same as last inspection.10/16/2012 Pumping plant abandoned. Pipe abandoned and only visible at bottom of concrete standpipe. Pipe needs to be abandoned properly. FIELD_STRUCT_DESC: 12-inch galvanized iron irrigation pipe through the levee, 6 feet below the crown. 10 horsepower (HP) pump in the canal, and power pole located on the waterside (WS). 36-inch concrete standpipe located on the landside (LS) shoulder. [Additional Reference(s): DWR Levee Log, 1990. USACE Sacramento O&M Manual 135, May 1953, (HLM 0.74), Page 11, Location Section 19, As-Built Drawing No. 50-10-2816]. FS Date: 4/12/2017 12:04:36 PM

Concrete base along WS toe.

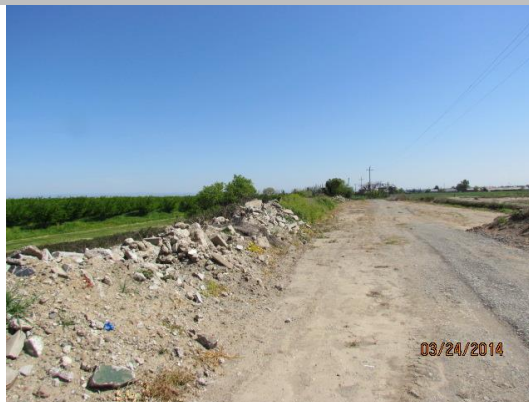
Photo 1 of 2 : SP_2018_ST0020_214_3_20180305_00001.jpg

LM Start	1.43	Rating **	M	Issue No.	3
LM End	1.52	Issue Type +	En	Location *	LS
Category	Earthen Levee			GPS Latitude/Longitude	
				Start	End
Item	Encroachments			39.170782 °	39.170865 °
				-121.700167 °	-121.698165 °
DWR ID	DWR_NA0020_02_s_2012_3				
Comment Code					
DE : Debris					
Inspector Comment					
Remove the broken concrete.

View of the piles of broken concrete.

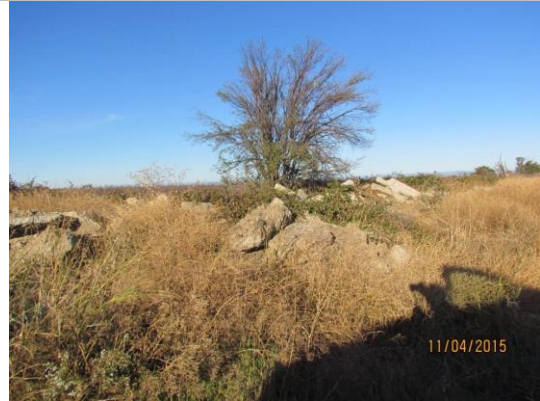
Photo 2 of 2 : SP_2018_ST0020_214_3_20180305_00002.jpg

LM Start	1.43	Rating **	M	Issue No.	3 (cont)	
LM End	1.52	Issue Type +	En	Location *	LS	
Category	Earthen Levee			GPS Latitude/Longitude		
				Start		End
Item	Encroachments			39.170782 °		39.170865 °
				-121.700167 °		-121.698165 °
DWR ID	DWR_NA0020_02_s _ 2012_3					
Comment Code						
DE : Debris						
Inspector Comment						
Remove the broken concrete.

View of the pile of broken concrete.

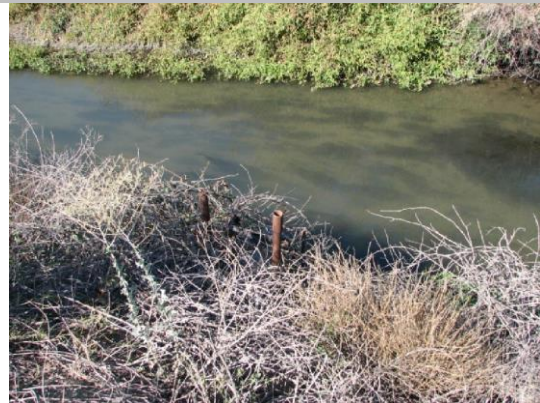
Photo 1 of 3 : UCIP_SP_2018_51539_11406.jpg

Comment Code					
Inspector Comment					
FS_ID:51539 DS_ID:19423 EP_NO: N/A Repair Type: Non-Urgent Crossing Status: Found UCIP Comments: 4/10/2017 LS inlet is buried, WS pipe outlet is overgrown with the flapgate being the only thing that is barely visible. (DWR Sutter Yard- AFreitag)10/11/2016 LS inlet is buried and WS flapgate is overgrown with blackberries.(DWR Sutter Yard - afreitag)4/19/2016 WS flapgate is completely overgrown with blackberries. 5/12/2015 LS inlet still buried with soil and blackberries on WS have blocked the flap gate.LS intake is filled and blocked with soil.11/17/2014 Ws outlet of pipe is overgrown and blocked from opening by blackberries. LS inlet still appears to be buried/blocked by soil.5/12/2014 Same as last inspection.11/4/2013 Same as last inspection.5/15/2013 Same as last inspection. FIELD_STRUCT_DESC: 16-inch corrugated metal drainage pipe through the levee, 5 feet below the crown. Flap gate located on the waterside (WS) end. Landside (LS) inlet filled and blocked with soil in 2012. [Additional Reference(s): DWR Levee Log, Revised 1990]. FS Date: 4/12/2017 12:07:34 PM

Pipe with flapgate at outlet on WS slope.

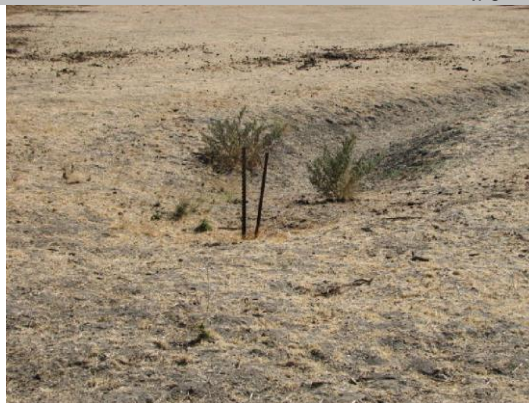
Photo 2 of 3 : UCIP_SP_2018_51539_11405.jpg

Buried inlet 30 feet from LS shoulder.

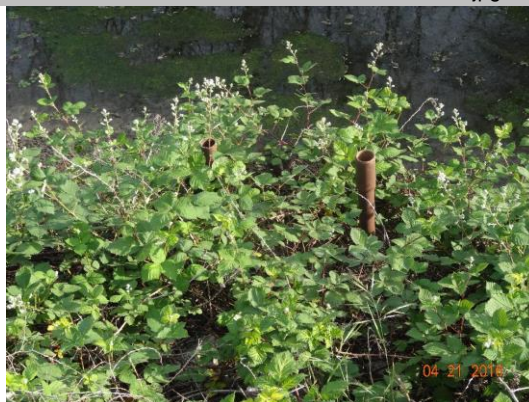
Photo 3 of 3 : UCIP_SP_2018_51539_74966.jpg

WS flapgate overgrown by blackberries

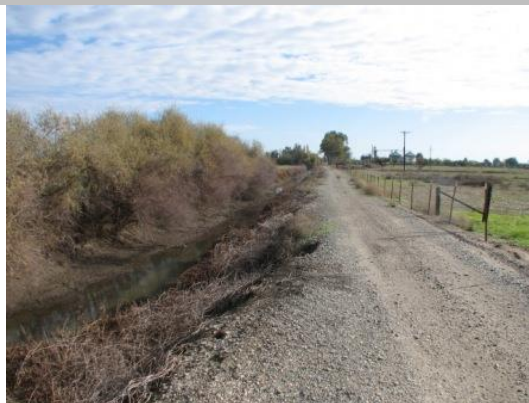
Photo 1 of 2 : SP_2018_ST0020_214_4_20180305_00003.jpg

View of the erosion along the waterside slope.

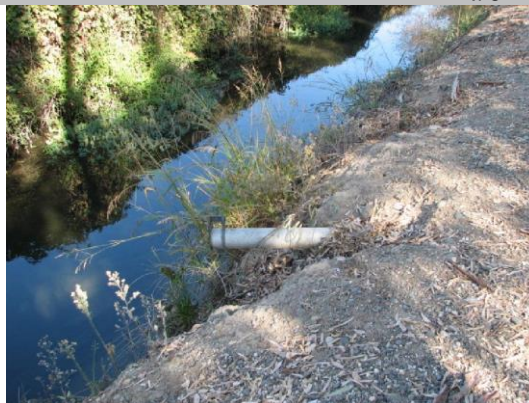
Photo 1 of 1 : UCIP_SP_2018_51542_14341.jpg

Comment Code						
Inspector Comment						
FS_ID:51542						
DS_ID:20122						
EP_NO: N/A						
Repair Type: Non-Urgent						
Crossing Status: Found						
UCIP Comments: 4/10/2017 Crossing appears to be in good condition.						
(DWR Sutter Yard- A Freitag)4/19/2016 Crossing appears to be in good condition.						
(DWR Sutter Yard - a Freitag)4/19/2016 Crossing appears to be in good condition.						
5/12/2015 Crossing appears in good condition. No noticeable issues to report.						
11/17/2014 Same as last inspection.						
5/12/2014 Same as last inspection.						
11/4/2013 Same as last inspection.						
5/15/2013 Same as last inspection.						
10/16/2012 No permit identified for crossing.						
FIELD_STRUCT_DESC: 7-inch flexible high-density polyethylene (HDPE) drainage pipe through the levee, 1 foot below the crown. No permit has been identified since crossing was field discovered in 2012.						
FS Date: 4/12/2017 12:29:06 PM

HDPE pipe on upstream side of aluminum pipe shown in picture.

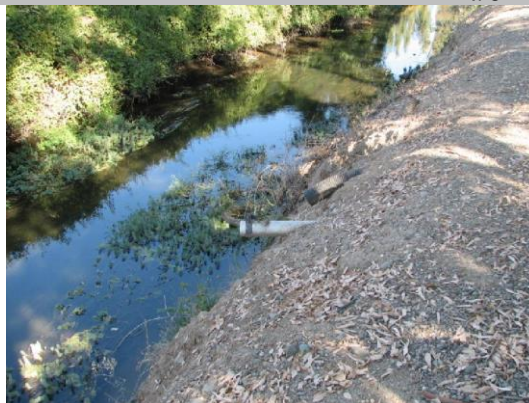
Photo 1 of 2 : UCIP_SP_2018_51543_14339.jpg

Comment Code						
Inspector Comment						
FS_ID:51543						
DS_ID:20120						
EP_NO: N/A						
Repair Type: Non-Urgent						
Crossing Status: Found						
UCIP Comments: 4/10/2017 Crossing appears to be in good condition.						
(DWR Sutter Yard- AFreitag)10/11/2016 Crossing appears to be in						
good condition. (DWR Sutter Yard - afreitag)4/19/2016 Crossing						
appears to be in good condition.5/12/2015 Crossing appears in good						
condition. No noticeable issues to report.11/17/2014 Same as last						
inspection.5/12/2014 Same as last inspection.11/4/2013 Same as						
last inspection.5/15/2013 Same as last inspection.10/16/2012 No						
permit identified for crossing.						
FIELD_STRUCT_DESC: 5-inch aluminum drainage pipe through the						
levee, 1 foot below the crown. Flap gate located on the waterside (WS)						
with concrete headwall block on the landside (LS). No permit has been						
identified since crossing was field discovered in 2012.

Pipe and flap gate on WS shoulder.

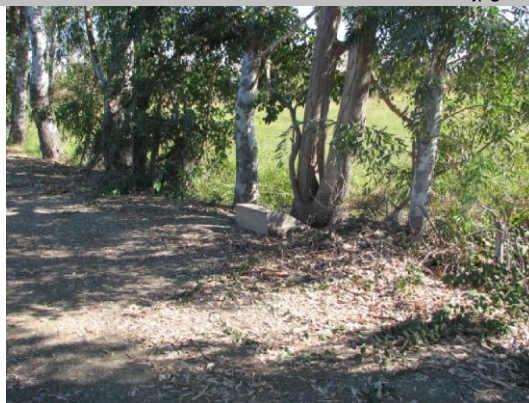
Photo 2 of 2 : UCIP_SP_2018_51543_14338.jpg

Concrete headwall on LS shoulder.

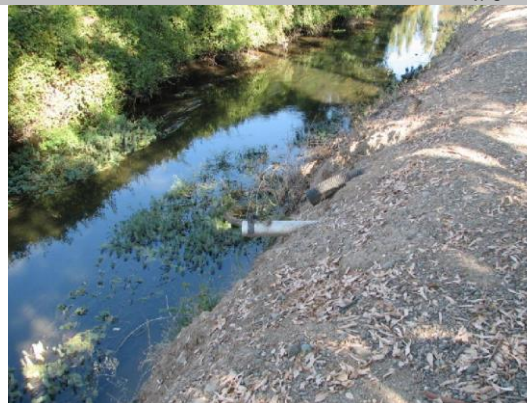
Photo 1 of 1 : UCIP_SP_2018_51544_14340.jpg

Comment Code						
Inspector Comment						
FS_ID:51544						
DS_ID:20121						
EP_NO: N/A						
Repair Type: Non-Urgent						
Crossing Status: Found						
UCIP Comments: 4/10/2017 Crossing appears to be in good condition.						
(DWR Sutter Yard- AFreitag)10/11/2016 Crossing appears to be in						
good condition.(DWR Sutter Yard - afreitag)4/19/2016 Crossing						
appears to be in good condition.5/12/2015 Crossing appears in good						
condition. No noticeable issues to report.11/17/2014 Same as last						
inspection.5/12/2014 Same as last inspection.11/4/2013 Same as						
last inspection.5/15/2013 Same as last inspection.10/16/2012 No						
permit identified for crossing.						
FIELD_STRUCT_DESC: 7-inch flexible high-density polyethylene						
(HDPE) drainage pipe through the levee, 1 foot below the crown. No						
permit has been identified since crossing was field discovered in 2012.						
FS Date: 4/12/2017 12:30:51 PM

HDPE pipe on WS shoulder.

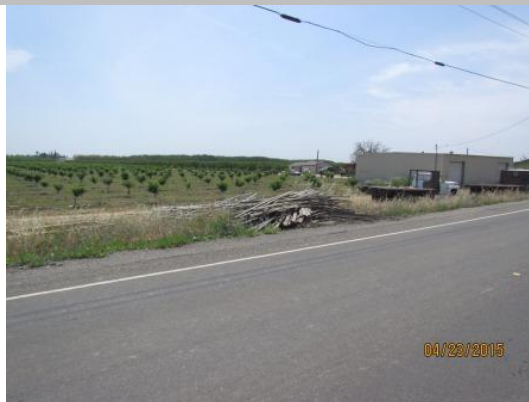
Photo 1 of 1 : SP_2018_ST0020_214_10_20180305_00007.jpg

View of the material, garbage, and equipment along the landside toe
